High Resolution Characterization of VOCs & Petroleum Hydrocarbons

Bruce Tunncliffe
Vertex Environmental Inc.

SMART Remediation
Vancouver, BC
January 27, 2015

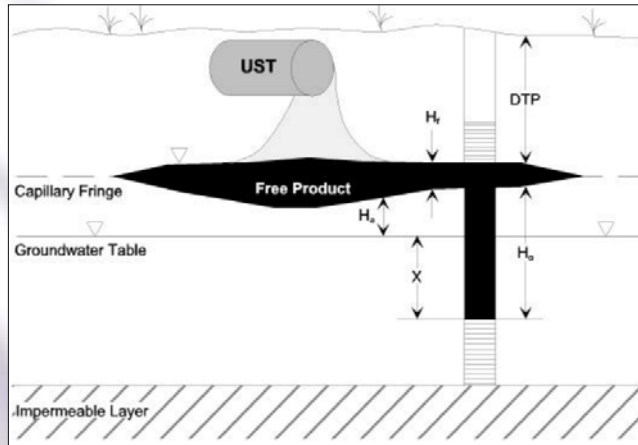
Contaminant Distribution vs Site Measurements

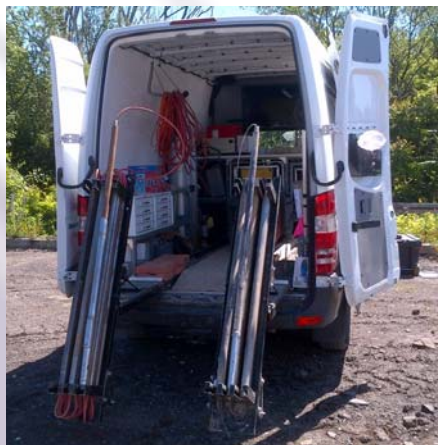
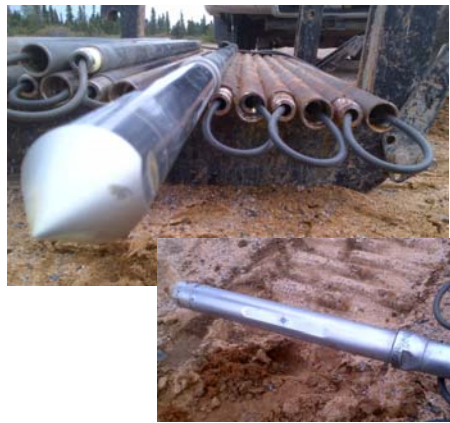
- Developed by US Army ('90s)
- UVOST: Ultra-Violet Optical Screening Tool
- Equipment
 - Direct push (Geoprobe)
 - Probe
 - Fibre optic cable

- Semi-Quantitative
- High Resolution
- Real Time

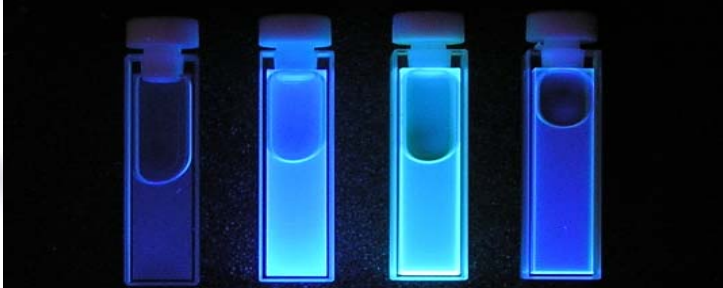
kerosene gasoline diesel oil

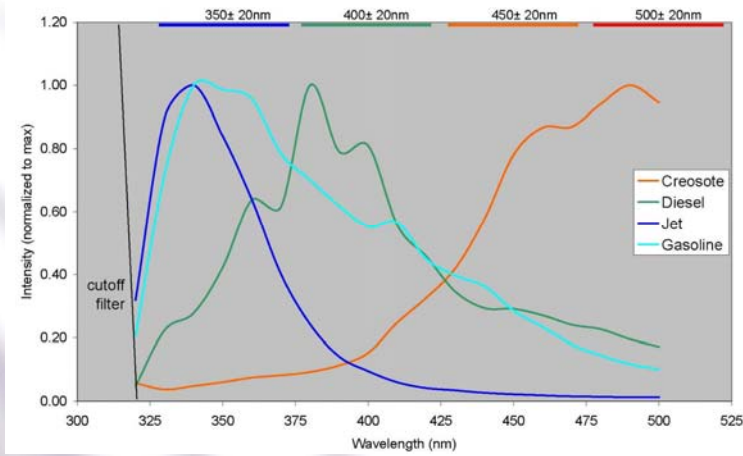
naphthalene

phenanthrene

pyrene

benzo[e]pyrene

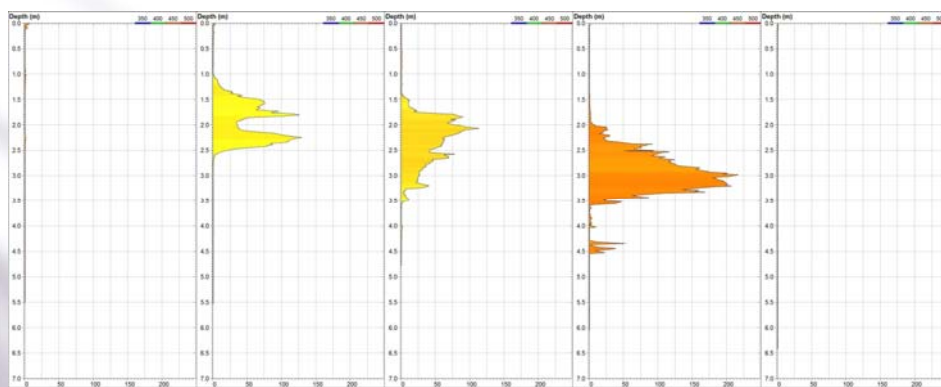
LIF Output

Cross Section of LIF Points

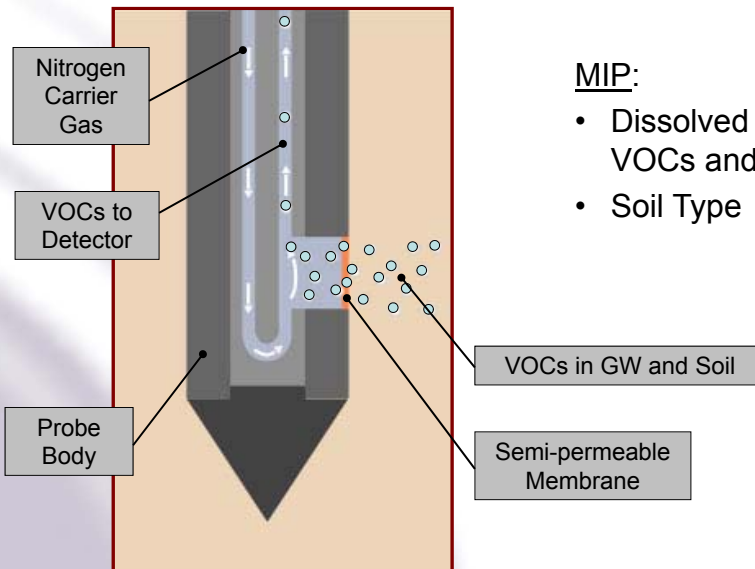
MIP:

- Dissolved Phase VOCs and PHCs
- Soil Type

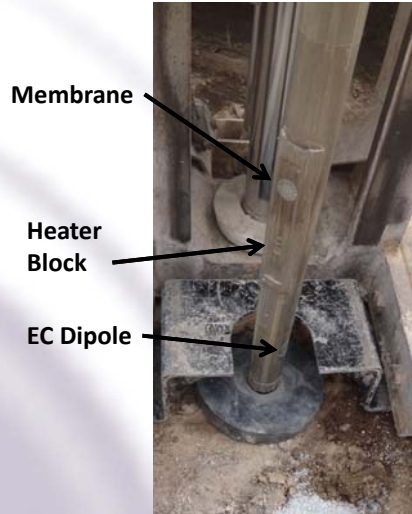
- Three detectors:
 - Photoionization Detector (PID)
 - Flame Ionization Detector (FID)
 - Halogen Specific Detector (XSD)
- Electrical Conductivity
 - Used to determine soil classification

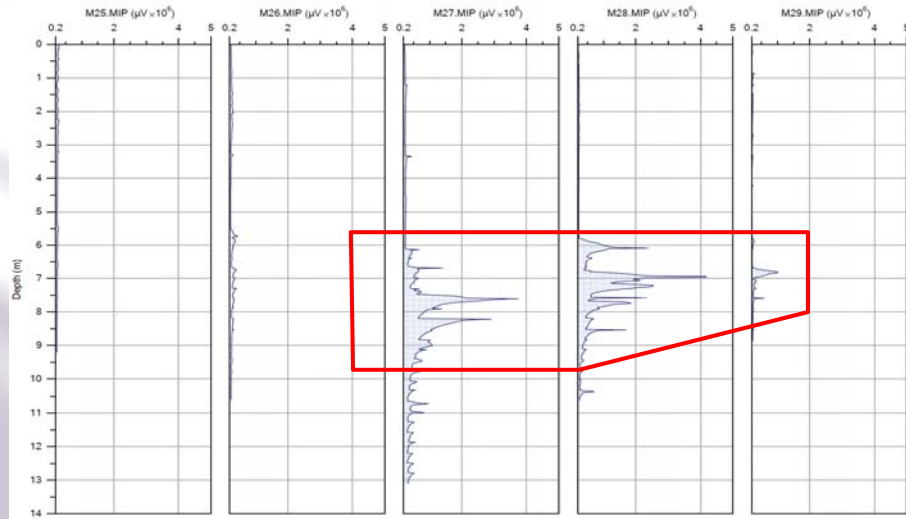
MIP Output

Cross Section of MIP Points

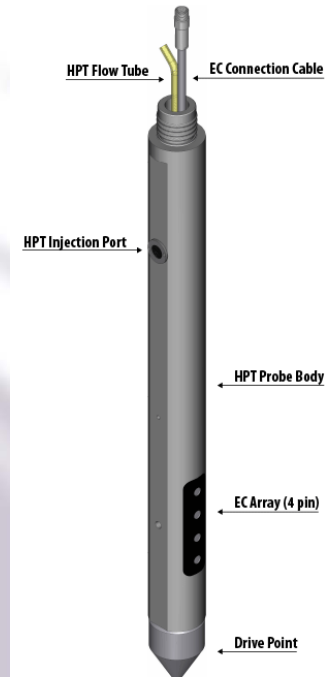
Hydraulic Profiling Tool

- Direct Push
- Assess Groundwater Permeability
- Water Injected into the Ground
 - Flow and Back-pressure measured
- EC: Estimate Soil Type
- Result: Hydraulic Conductivity
 - on a cm scale

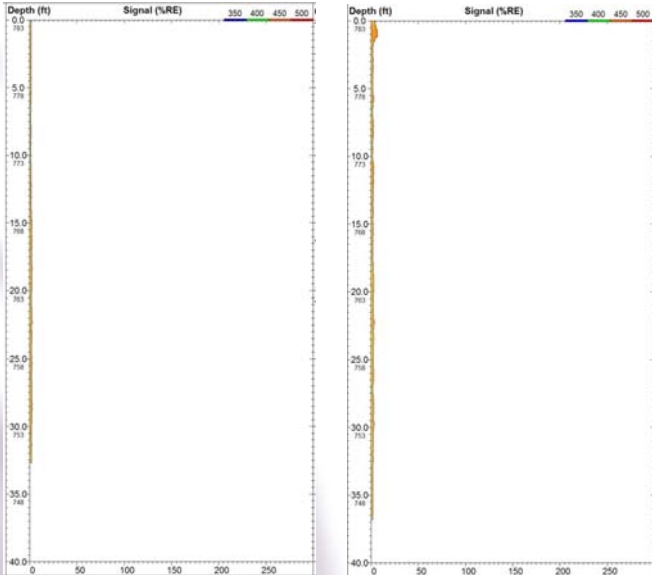
LIF Results

No NAPL detected

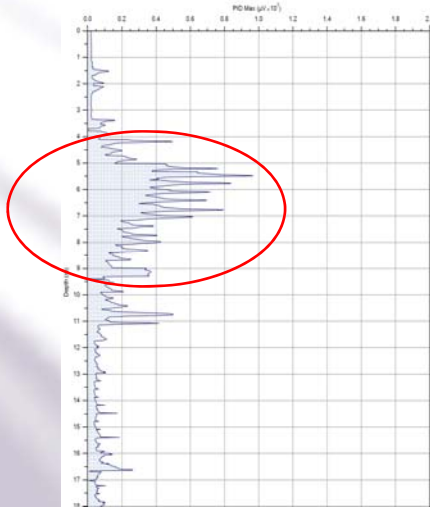
Case Study - Oxidant Loading Rates

Original Design: Inject 29.6 kg/m
from 3 m to 23 m bgs

Original Design (kg/m)	Re-Design (kg/m)	Depth (m)
0.0	0.0	0 m
29.6	38.0	3 m
	44.3	
	31.7	
	25.3	
	19.0	23 m

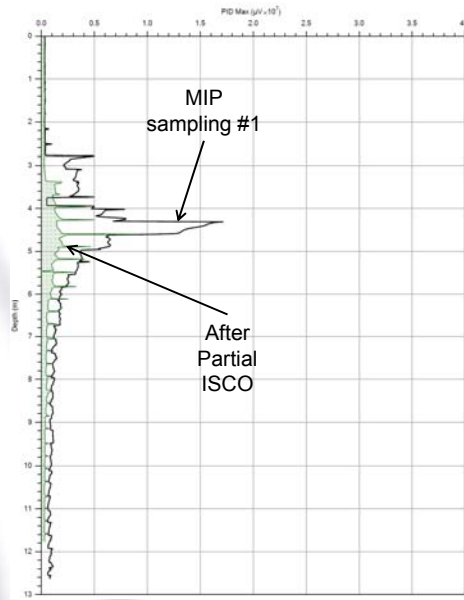
MIP Results

MIP PID Results

Interim MIP sampling

Fall 2011
Black Line

After Partial ISCO

Summer 2012
Green Line

Location

Core of Injection

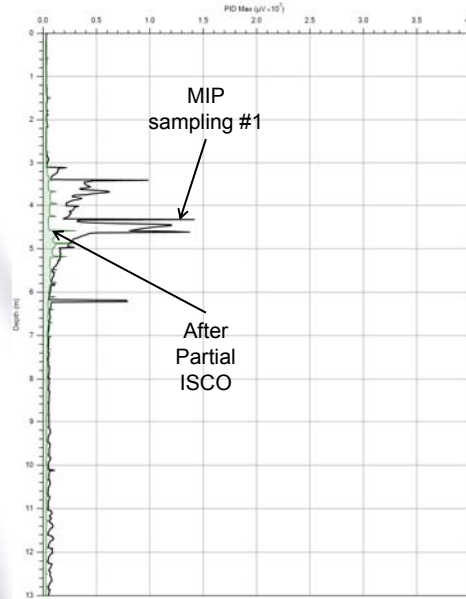
MIP Results

MIP PID Results

Interim MIP sampling

Fall 2011
Black Line

After Partial ISCO

Summer 2012
Green Line

Location
East Edge of the Core of Injection

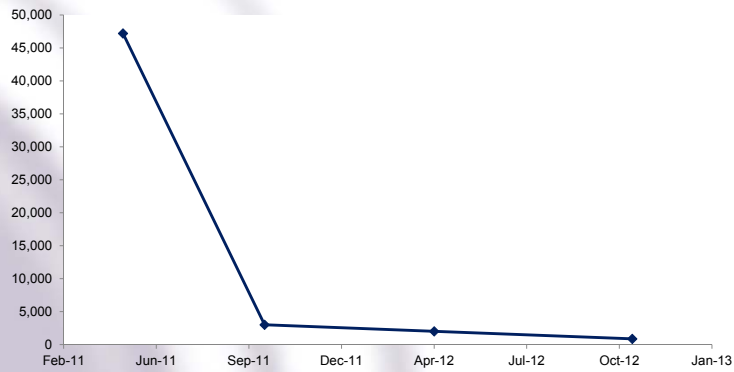
Case Study – Analytical Results

Parameter	Units	Groundwater Standards	JHL2-II (11 m, 35 ft)				% Reduction
			May-11	Oct-11	Apr-12	Nov-12	
Total BTEX & PHCs	ug/L	-	47,190	3,026	2,017	894	98
PHC(F1-C6 to C10)	ug/L	750	25,000	<130	850	530	98

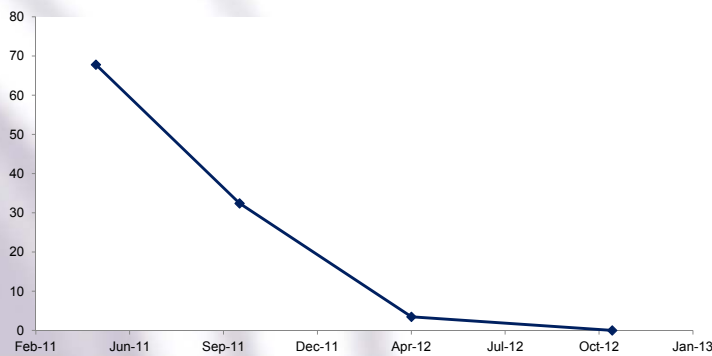
Case Study – Analytical Results

Parameter	Units	Groundwater Standards	ECO-1				% Reduction
			May-11	Oct-11	Apr-12	Nov-12	
Total BTEX & PHCs	ug/L	-	68	32	4.0	<0.40	
Benzene	ug/L	5.0	51	12	4	<0.2	100
PHC(F1-C6 to C10)	ug/L	750	<100	<25	<25	<25	-
