*Case Study: Arsenic Groundwater Remediation Using a
Zero Valent Iron (ZVI) Permeable Reactive Barrier (PRB)
and ZVI Injection*

Jeff Burke
Milestone Environmental Contracting Inc.

SMART Remediation
Vancouver, BC
January 27, 2015

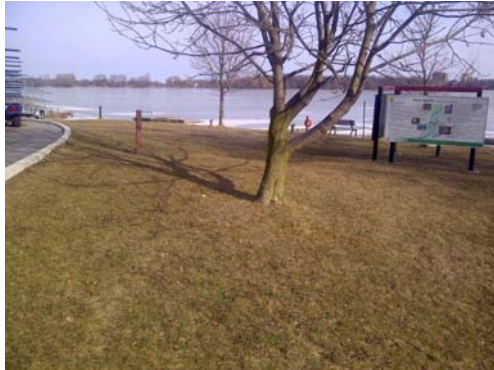
- Former site of tanning and lead smelting operations
- Currently a rowing / canoe club and public park
- Significant soil and groundwater impacts from arsenic
- Relatively minor chromium, lead, and mercury impacts
- Concern over discharges to the Cataraqui River and Lake Ontario

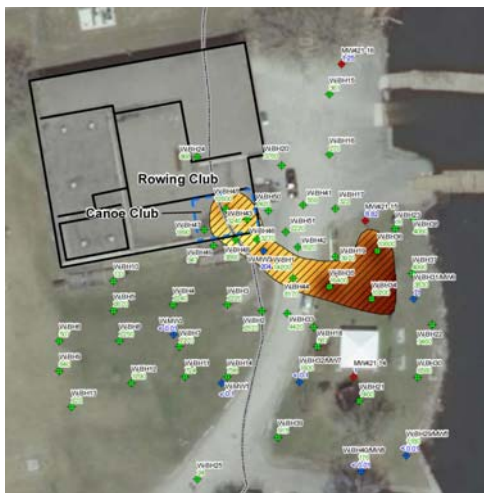
- Soils were leachate toxic waste for arsenic
- Soil up to 16,400 ppm arsenic vs. 18 ppm Table 9 SCS
- Groundwater up to 204,000 ppb arsenic vs. 1,500 ppb Table 9 SCS

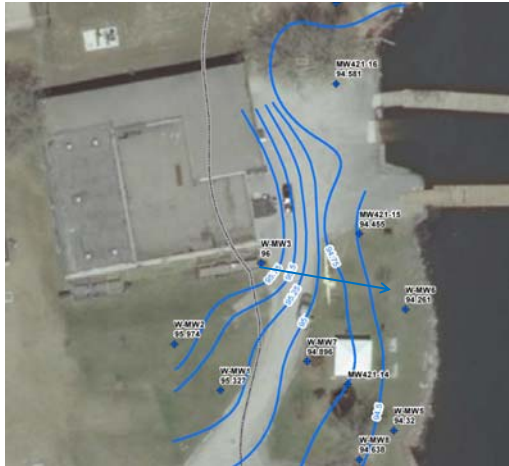
- Groundwater flow estimated 5 m/year
- Arsenic Impacted groundwater at 2-4mbgs

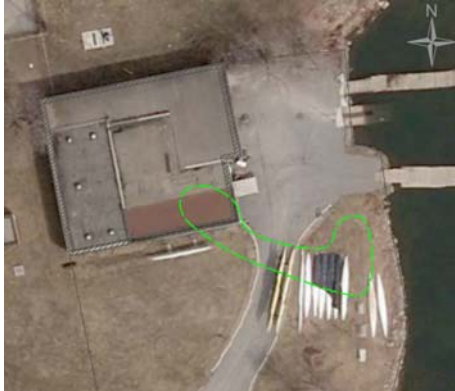
Original Scope

- Excavate and dispose of over 1,000 mt of soil
- Estimated \$500/mt disposal cost
- Excavation Dewatering
- Sub-Grade Cut-Off Wall Installation
- Vertical Groundwater Extraction Well
- Backfill/Restoration

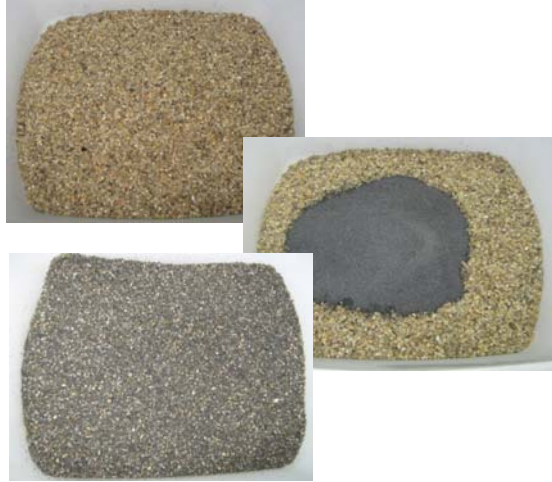
- Prepared 4 bench-scale tests and 2 control tests
- Groundwater control test (no media)
- Media control test (100% coarse sand)
- ZVI design (20% ZVI, 80% coarse sand)
- Enhanced ZVI Design (20% ZVI, 2% enhanced ZVI media, 80% coarse sand)
- Benthic sediment (150g) was added due to sulphate reducing properties

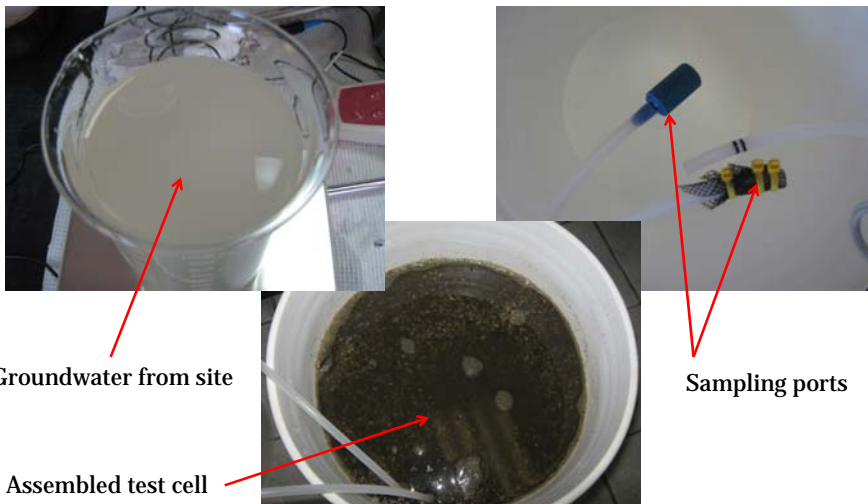
Groundwater from site

Assembled test cell

Sampling ports

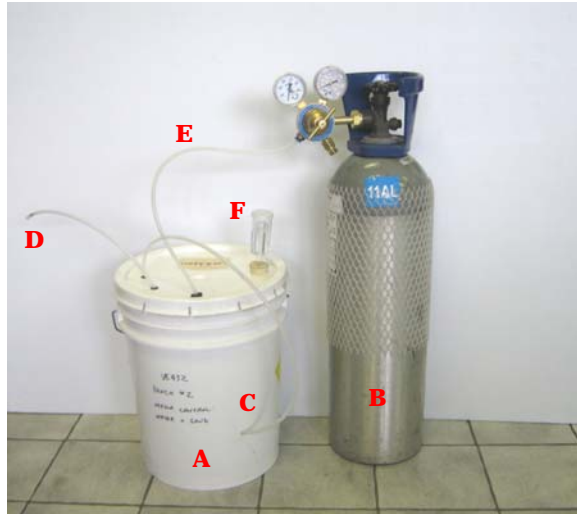
- A. HDPE Test Cell
- B. Nitrogen Tank
- C. Primary Sampling Port
- D. Secondary Sampling Port
- E. Injection Port
- F. Airlock

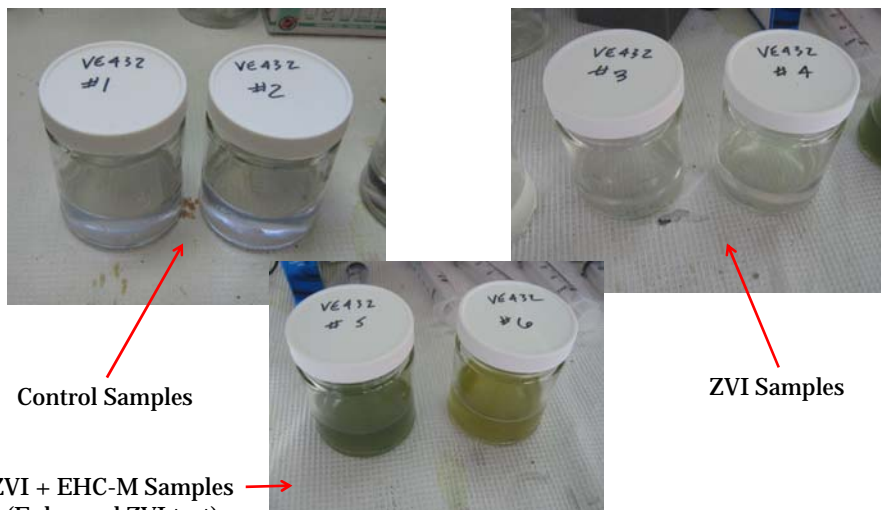
Control Samples

ZVI Samples

ZVI + EHC-M Samples
(Enhanced ZVI test)

- Within three (3) weeks arsenic concentrations in groundwater dropped from 23,100 ppb to average of 87 ppb in test cells (**99.6% reduction**) and to average of 3.6 ppb after four (4) weeks (**99.98% reduction**)
- MOE Table 9 site condition standard = 1,500 ppb
- ZVI PRB concept proven decisively
- Noting substantial cost-savings and enhanced environmental sustainability, contract was awarded to Milestone for ZVI-PRB installation

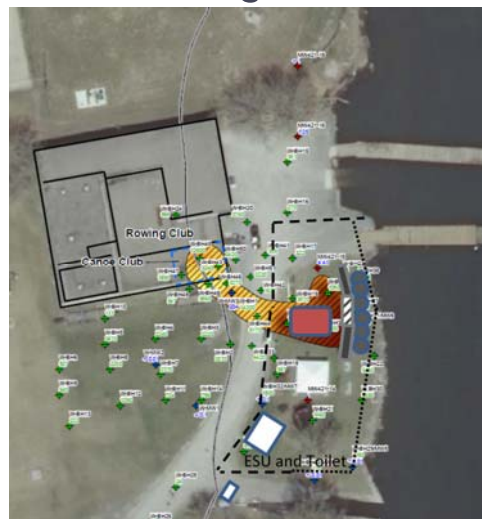
ZVI-PRB Design

- Wall design retention time was >2 months, more than sufficient to achieve good treatment
- PRB lifespan estimated at >20 years
- Both “keyed” into silty clay till &/or bedrock

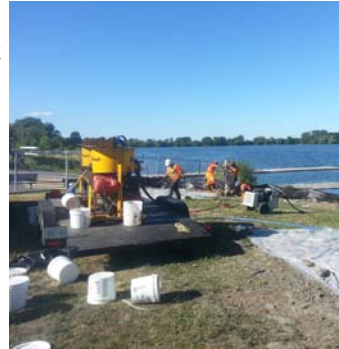
- Injected PRB installed first near shoreline (3 day program)
- Two (2) test boreholes advanced & sampled to confirm depth of “confining layer”
- Total of eleven (11) temporary injection points on a 1.5 m spacing from 1.5 to 3.5 mbgs
- Total of 2,450 kg micro-scale ZVI in a 30% slurry with 1.5% guar gum and water (8,100 L total)

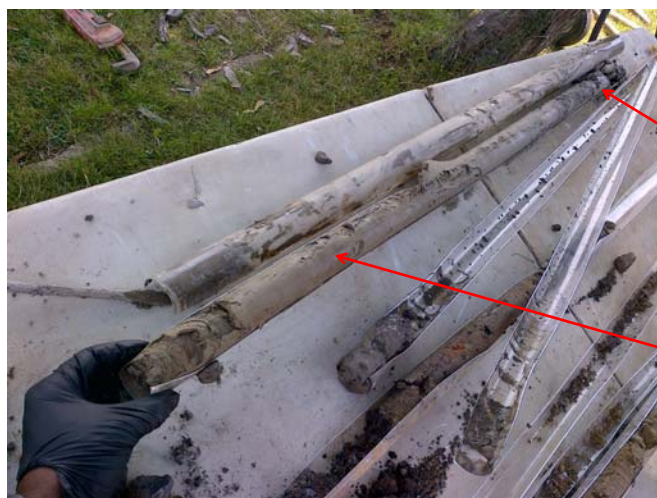
Upper fill soils

Silty clay till
“confining layer”

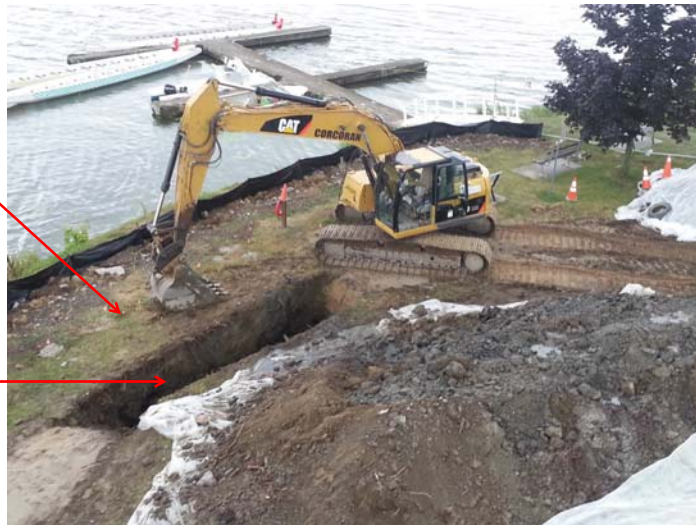
Line of temporary points for injected PRB

Excavation for "cut & fill" PRB

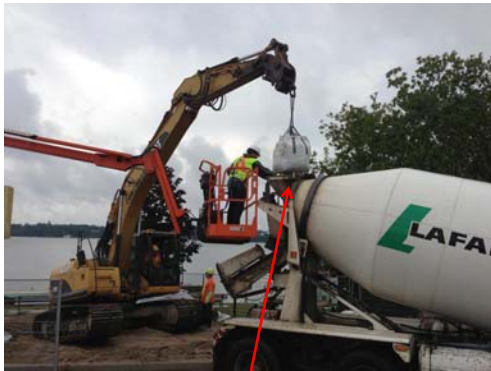
Macro-scale ZVI mixed with
concrete sand in cement truck

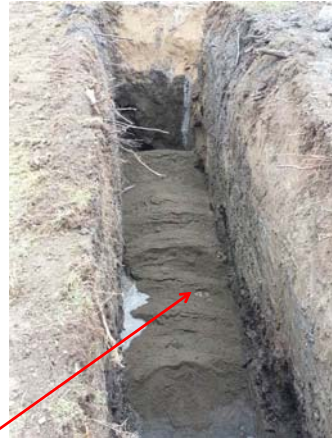
Macro-scale ZVI & concrete sand
mixture placed into excavation

- PRB was 5.2 m long, 1.0 m wide and from 2.0 to 3.8 mbgs “keyed” 0.5 m into silty clay till
- Total of 9,000 kg macro-scale ZVI mixed with 12,600 kg “concrete sand”
- One (1) day to direct place in two (2) loads
- Vertex completed QC/QC testing on batches of ZVI/sand mixture (magnetic separation)
- Target minimum 30% ZVI by weight; results were 40.5% & 43.2%, averaging 41.9% ZVI

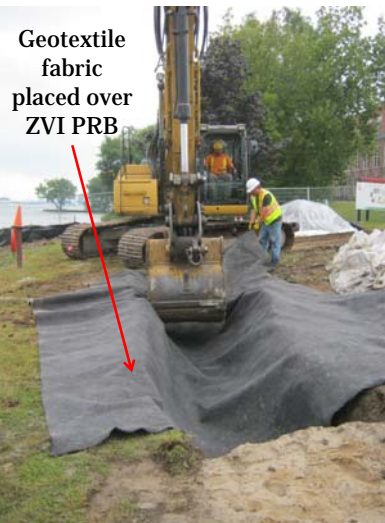
Geotextile
fabric
placed over
ZVI PRB

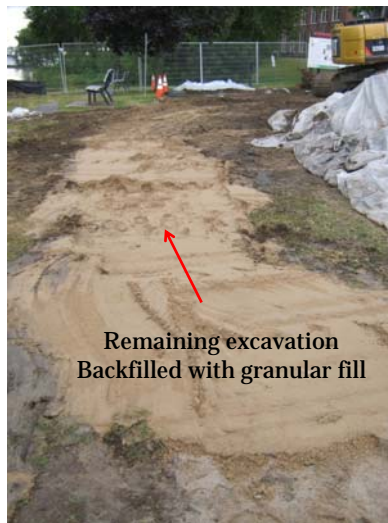
Remaining excavation
Backfilled with granular fill

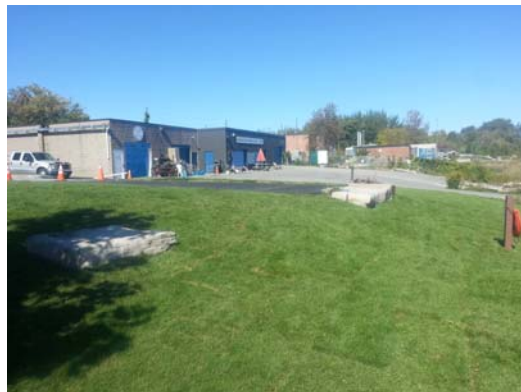
- City has installed monitoring wells up and down gradient the PRB wall
- Following post construction As spike, all results have been positive

- **Measure GW Arsenic levels have been cut in half between Dec. 2013 and Oct 2014**
- **pH levels are rising which is a signal that the ZVI is starting to react**
- **ORP levels DO levels are falling - trending in the right direction**
