ENVIRONMENTAL FRACTURING TO ACHIEVE SUSTAINABLE REMEDIATION IN DIFFICULT LITHOLOGIES

Presented by: Gordon Bures, M.Eng., P.Eng.

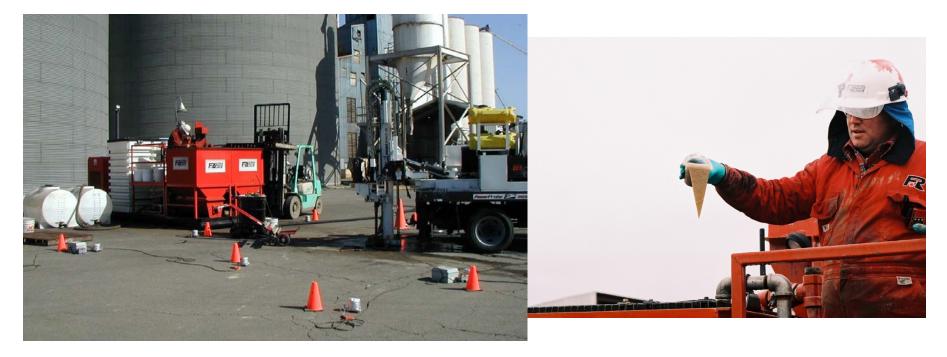
Field set up for Environmental Fracturing

- Mobile mixing and pumping unit
- Specialized downhole fracture tooling
- Drilling Equipment
- Data Acquisition System (Pressure, Rate vs. Time)
- Geophysical Fracture Mapping Equipment
 FRAC RITE ENVIRONMENTAL LTD.

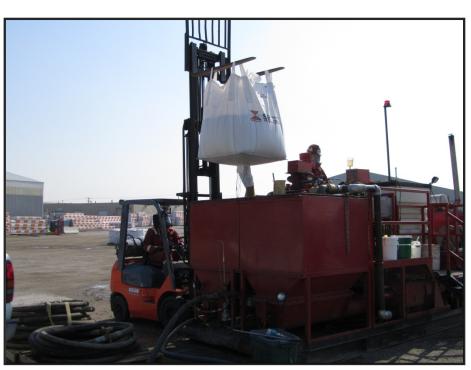
Initial Remedial Treatment

2011 Month	Oxidant / Proppant	Volume
June – July	Sand & Surfactant	106,000 L & 600 L
July	Sodium Persulfate & Hydrogen Peroxide	20,800 L & 7,250 L
September	Sodium Persulfate & Hydrogen Peroxide	9,300 L & 29,500 L
December (Off-site)	Calcium Peroxide & Hydrogen Peroxide	5,000 L & 5,000 L

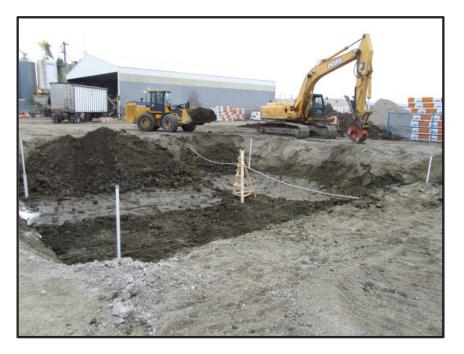
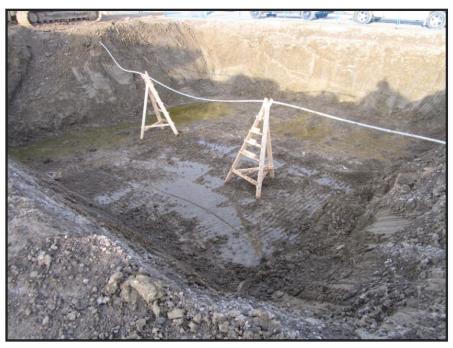
Limited Excavation (2012)

- A "hot spot" area was located on the east side of the plume
- A total of 900 tonnes of contaminated soil was disposed (<10% of total) in an area of 15 x 15 m and 1.5 to 3.5 m bgs
- Work completed during April 2012

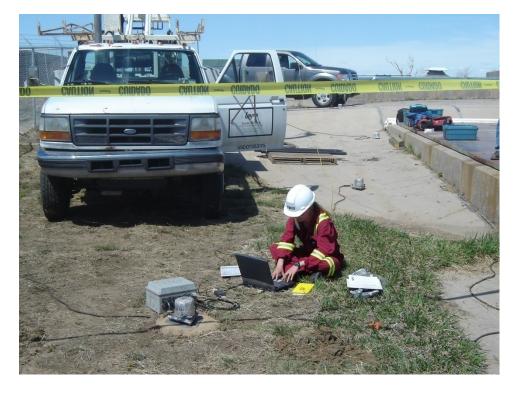
Fracture Mapping using Tiltmeter Geophysics

• Tiltmeters are ground surface sensors that detect tilt angle and tilt direction in response to a fracturing or injection event in the subsurface
